INSTITUTO TECNOLÓGICO DE
LA ENERGÍA

TEST REPORT	
UNE 21186:2011//NF C17-102:2011 Lightning protection: Early streamer emission lightning conductor	
TEST REPORT	IE-ITE-130912-02/M4/EN
Customer: Address:	Lightning Protection International Pty Ltd Patriarch drive, 49, Hungtingfield Tas, 7055, Australia
Test specification: Standard/s: Test procedure: Deviations: Non-standard test method:	UNE 21186:2011// NF C17-102:2011 PE-ITE-21186 N/A N/A
Sample description: Date of receipt:	Stormaster 30 SS 2014-02-11
Period of tests:	2014-02-12 / 2014-03-06
Issued by: INSTITUTO TECNOLÓGICO DE LA ENERGIA (ITE)	Testing location: <input checked="" type="checkbox"/> Edificio Institutos 8A, U.P.V. Camino de Vera, s/n 46022 Valencia (Spain) <input type="checkbox"/> Parque Tecnológico de Valencia – Av. Juan de la Cierva, 24 – 46980 Paterna (Spain)
Performed by: Jorge Moreno	  Job title: Lab Technician
Reviewed by: Anabel Soria	  Job title: Lab Coordinator
The results contained in this report, in accordance with requested tests, refers exclusively to the objects under test identified therein. Tested in the manner and date indicated in this report.

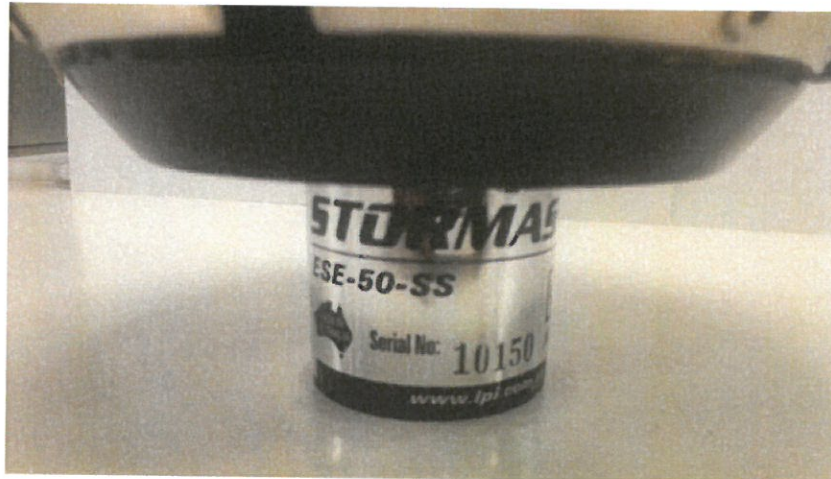
NOTE: The marking of the sample was in a ESE prototype, renamed after the test as "Stormaster 30 SS"

Figure 1. ESE's marking.

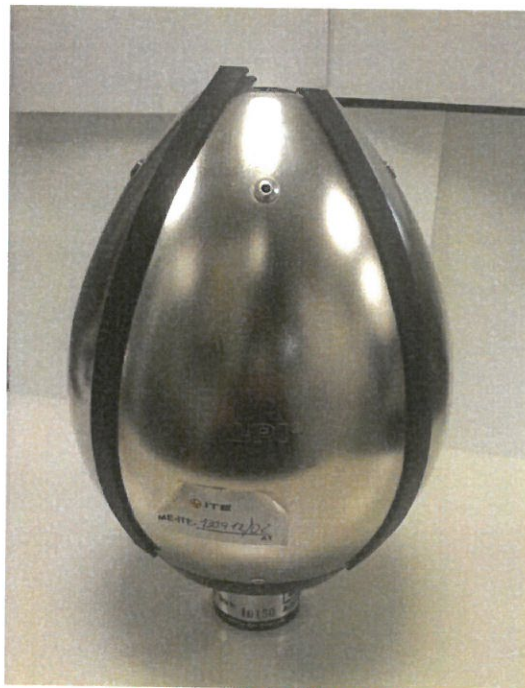
Figure 2. ME-ITE-130912/02

The ESE's marking is engraved on its body (LPI and Δt) and also printed on a sticker in the lower part.

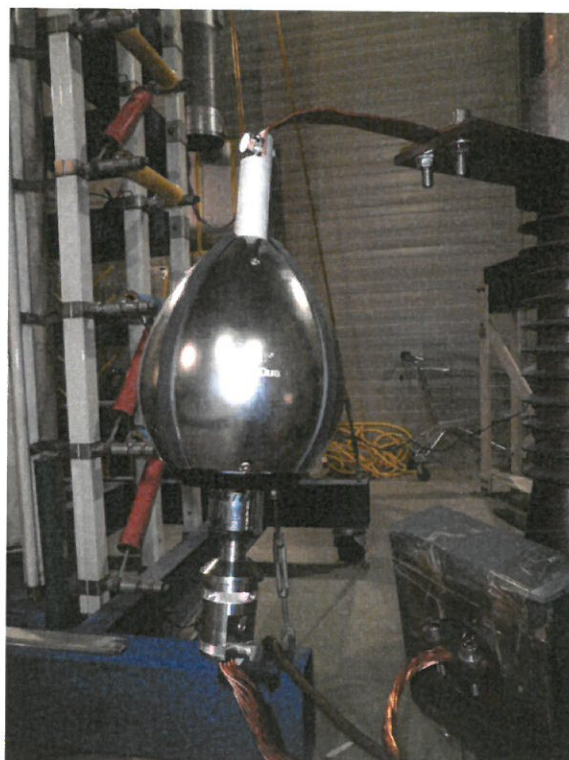
Test: **Withstand current test (C.3.4)**
Test conducted after environmental preconditioning and without cleaning the sample. Then sample is subjected to the current surge test (I_{imp}).

Figure 3. Electric Test.

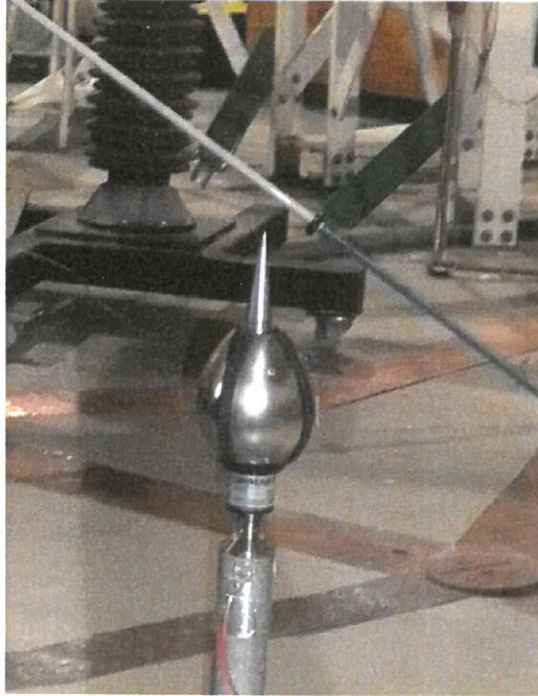
Test: **Determination of ESE advance time (C.3.5.3 UNE 21186 :2011 / C.3.5.2.4 NF C17-102 :2011)**

The advance time is determined relative to a reference wave defined by a rise time $T_s = 650$ ms and as defined in the standard.

Figure 4. Early Emission Test

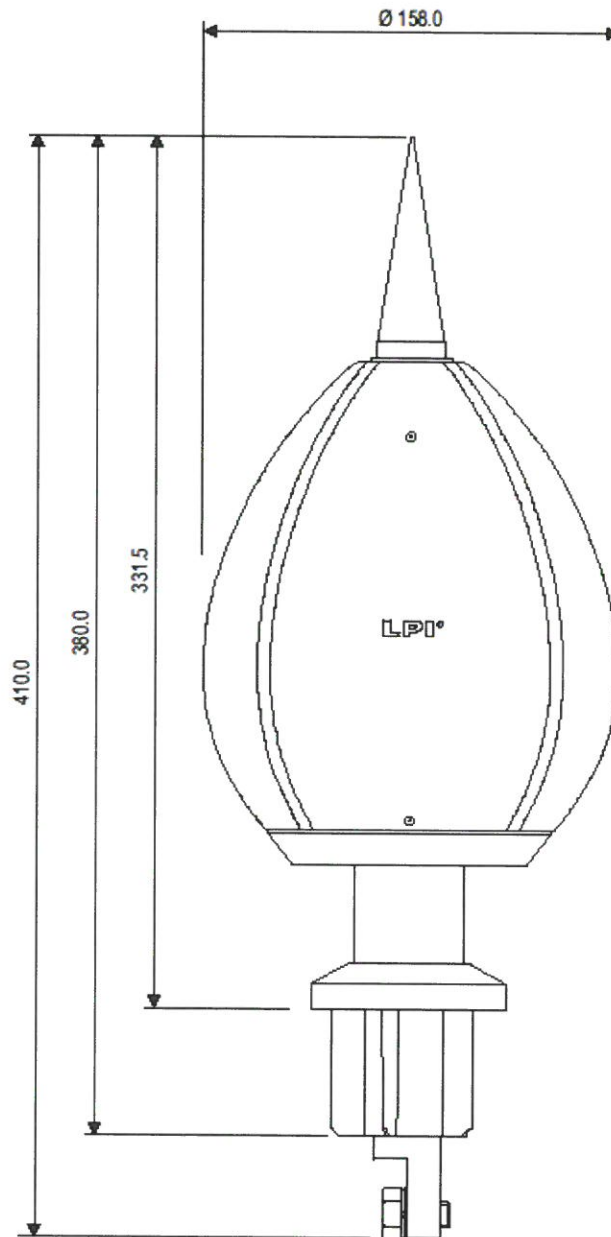
Figure 5. ESE's descriptive drawing.

Test: **Mechanical tests (C.3.2)**
Checking the dimensional tolerances according to the manufacturer's data and drawings.
